AffinityWater

Barn Meadows and Pondwicks Meadow

River Restoration Construction
Photographs

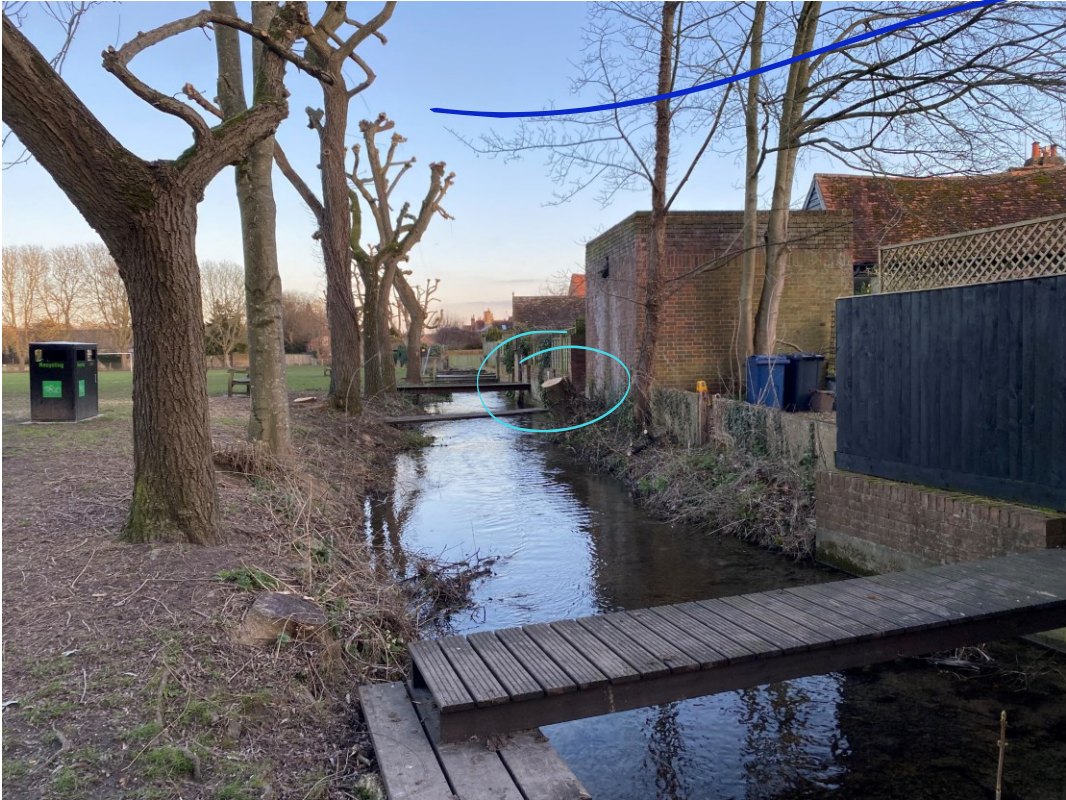
**Feb 2023 – Willow Pollarding
(& tree removal)**

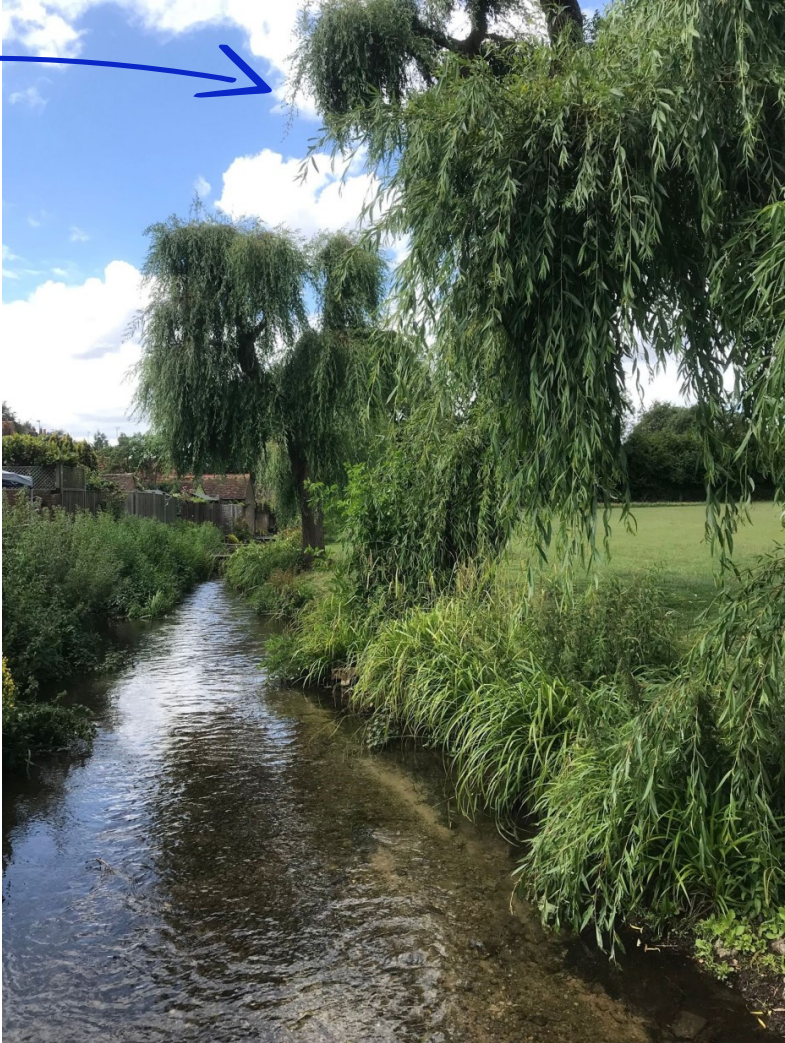
July 2023 – Willow Growth

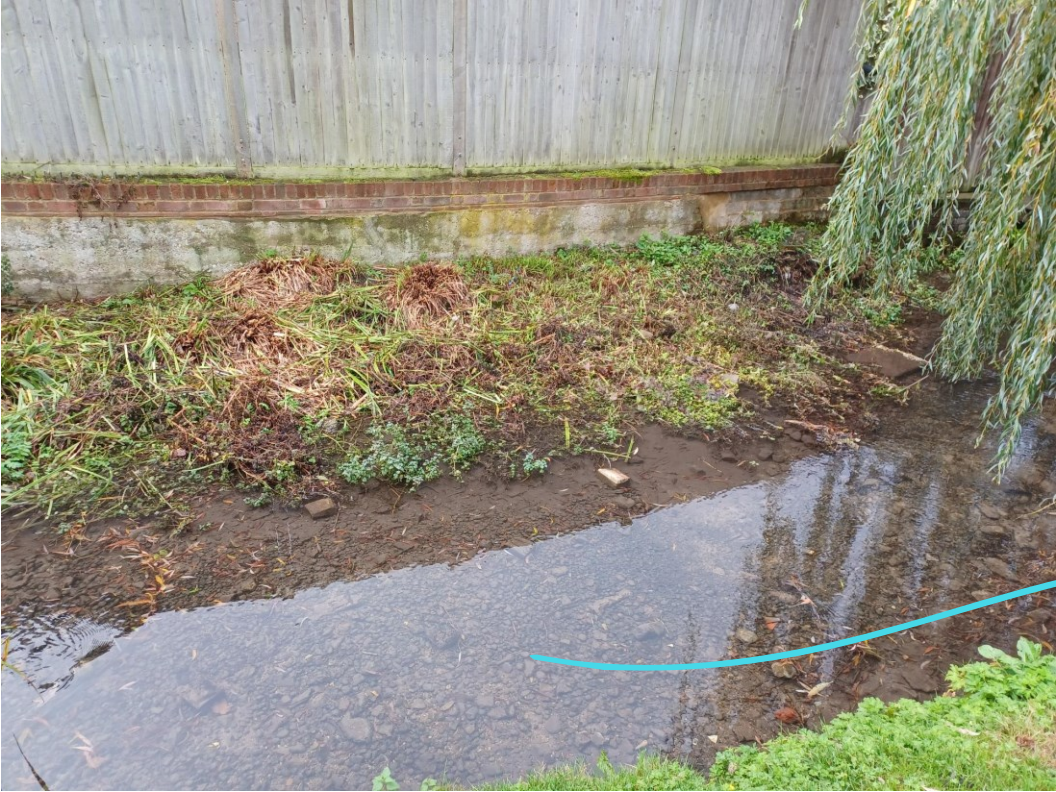
Before – heavy silt deposition caused by low flows

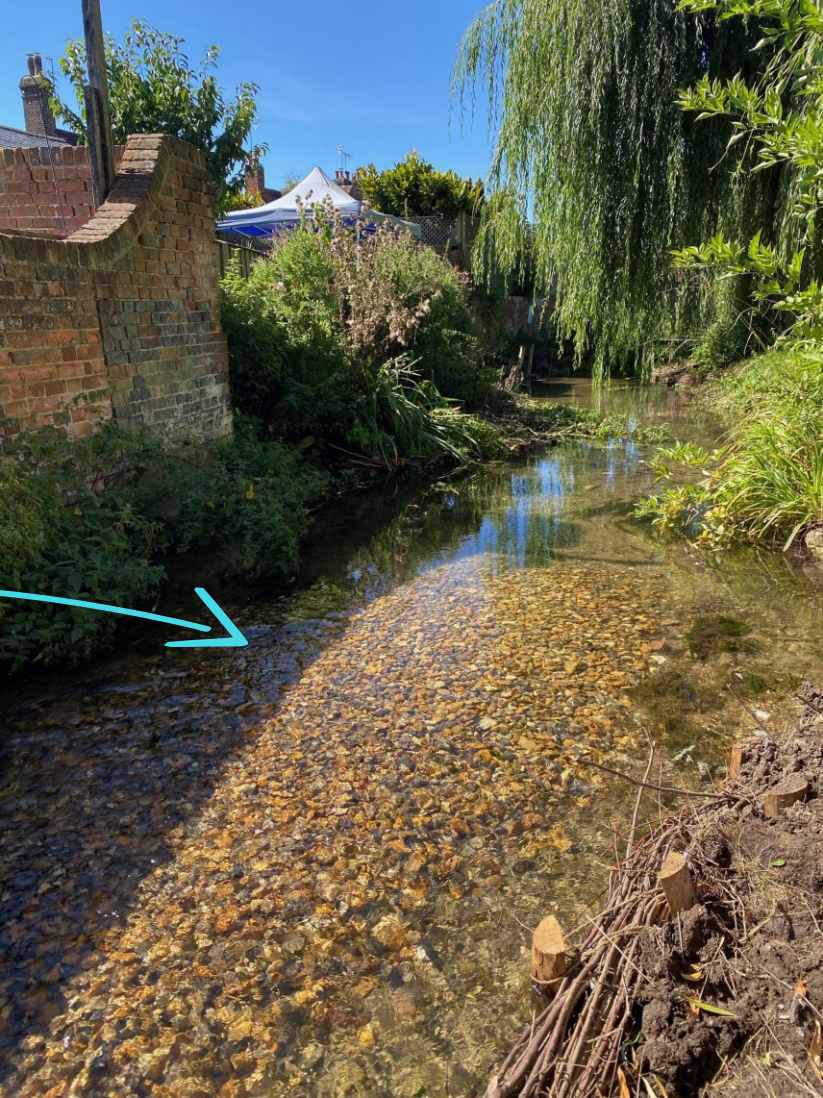
After – clear gravels

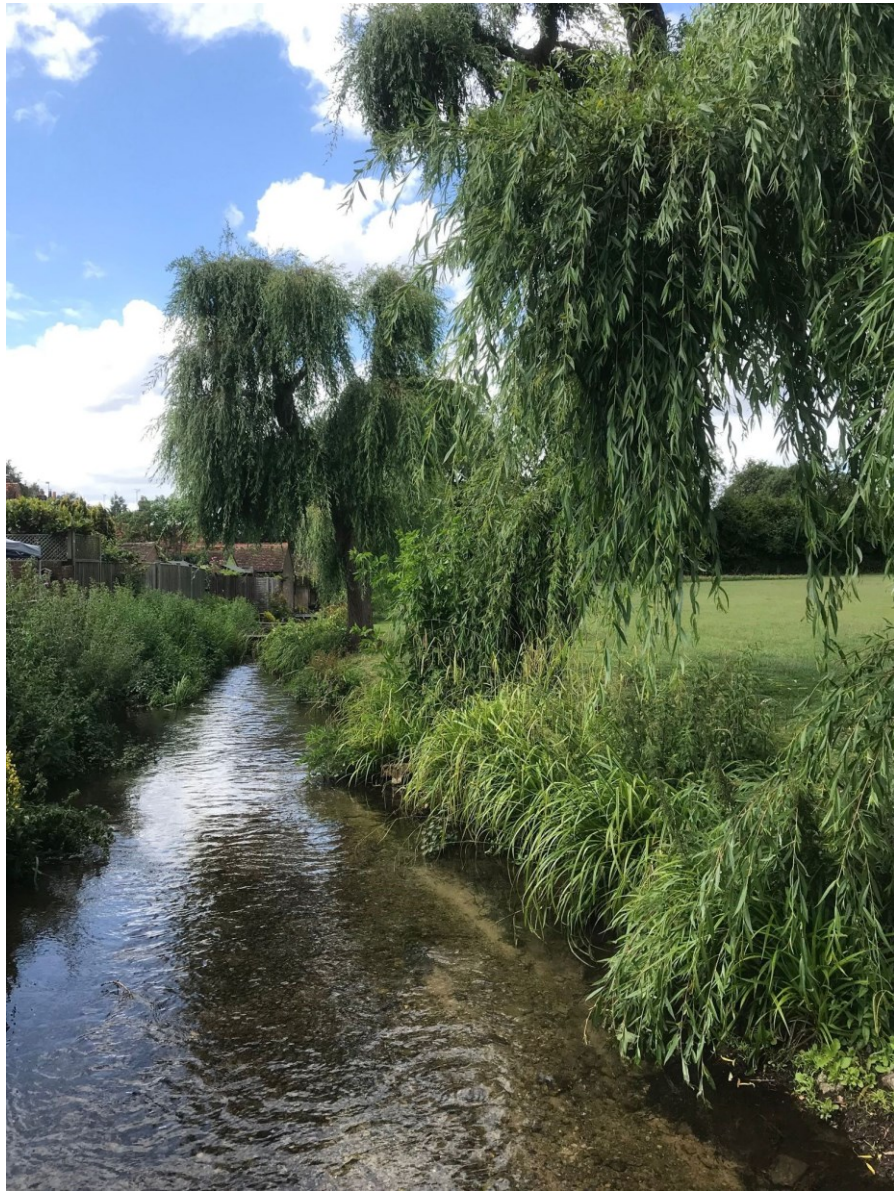
Before – straight silted channel

Earth berms

Small meanders

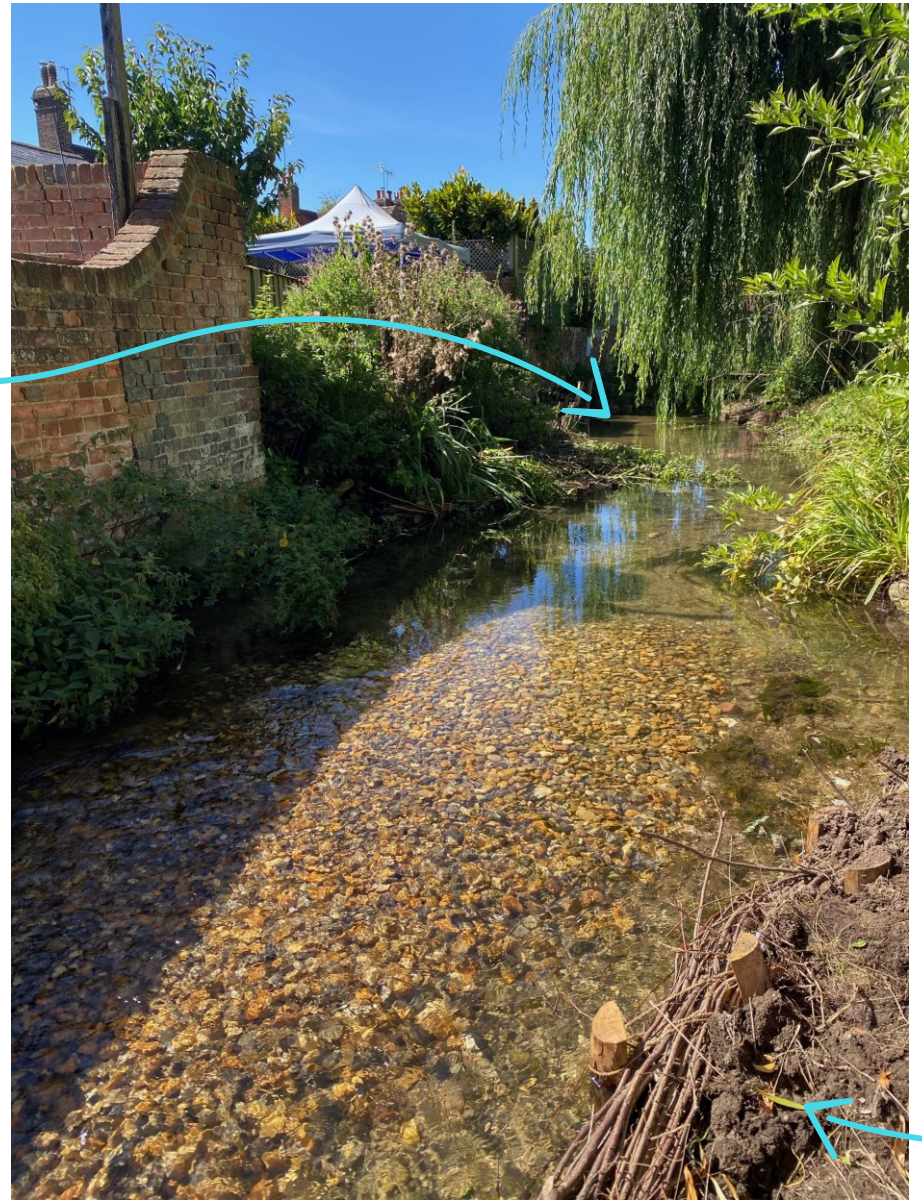
After – small meanders

Earth
berm

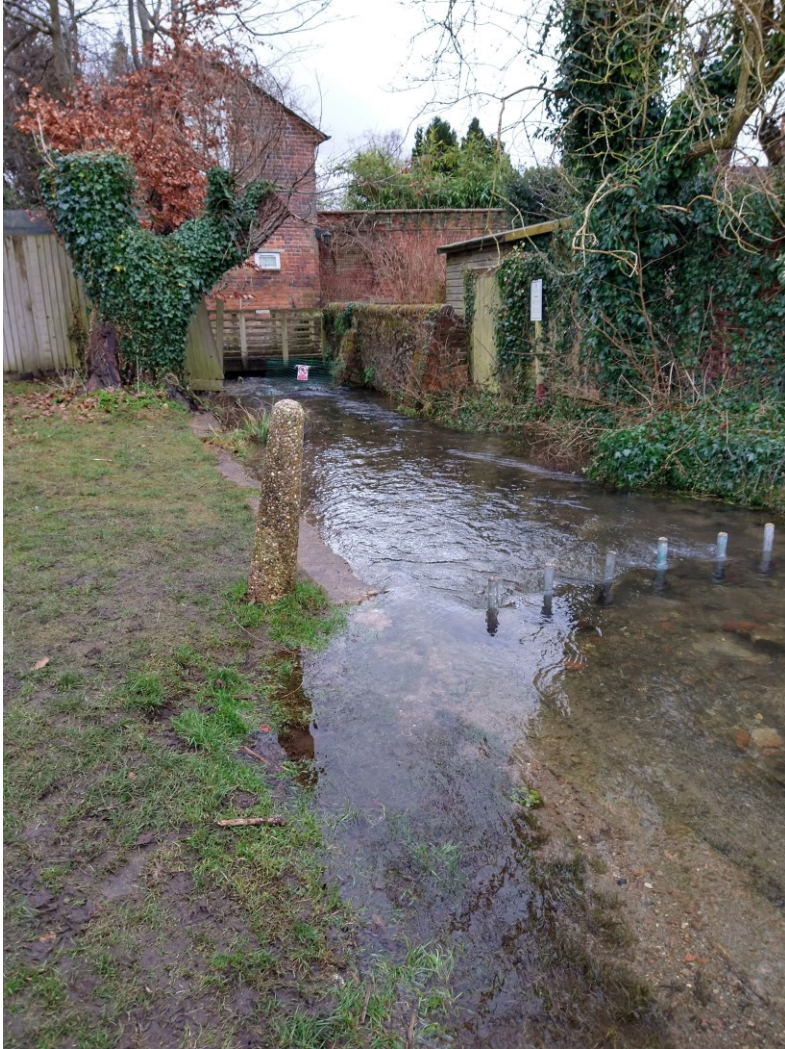
Before - channel during medium-high flows

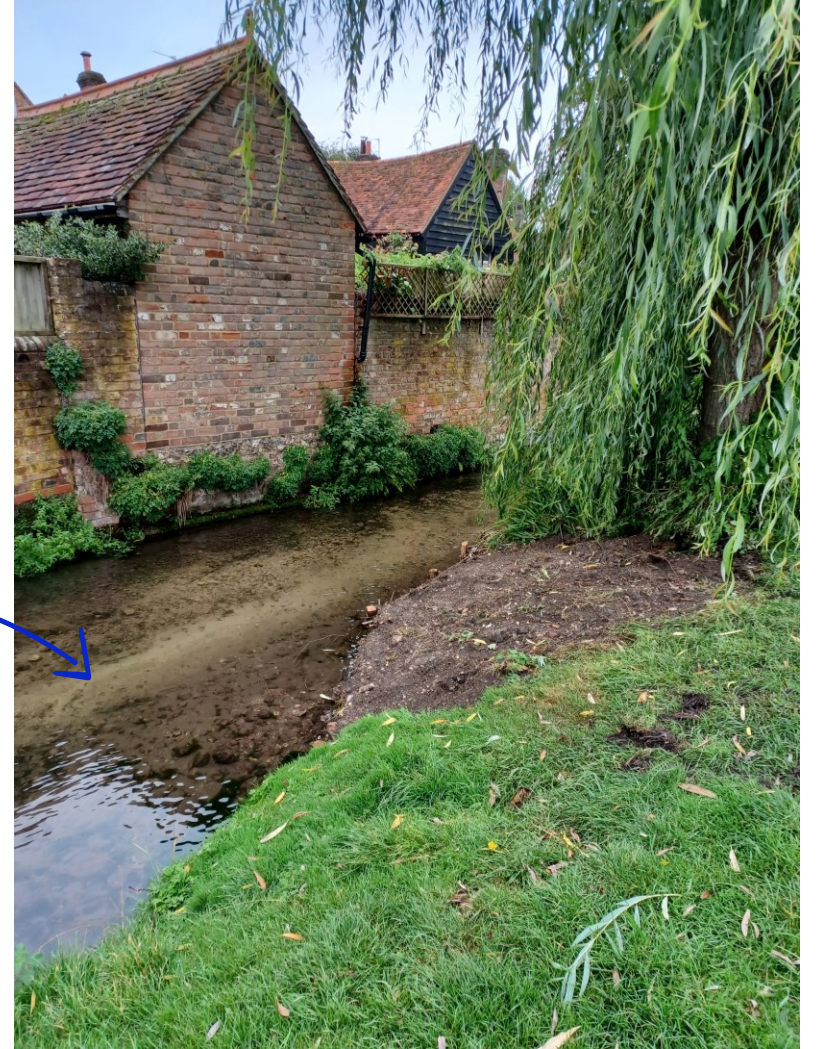
Low flow channel

During – low flow channel

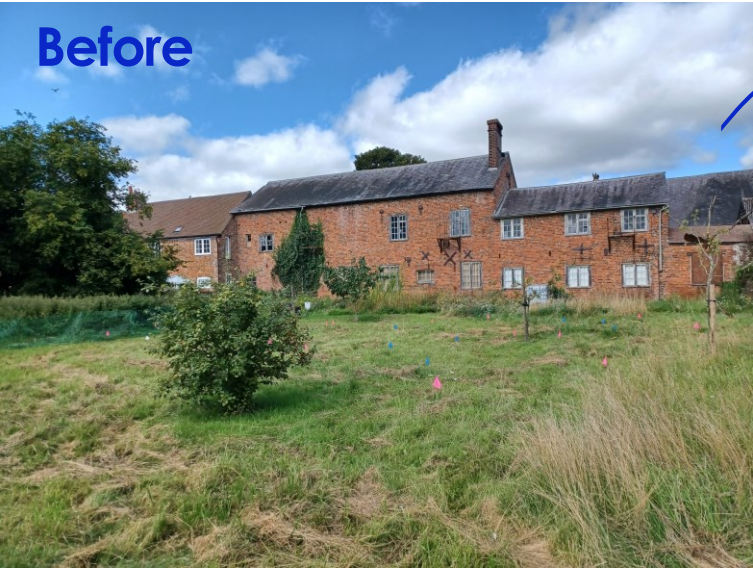
Before

Backwaters at Pondwicks

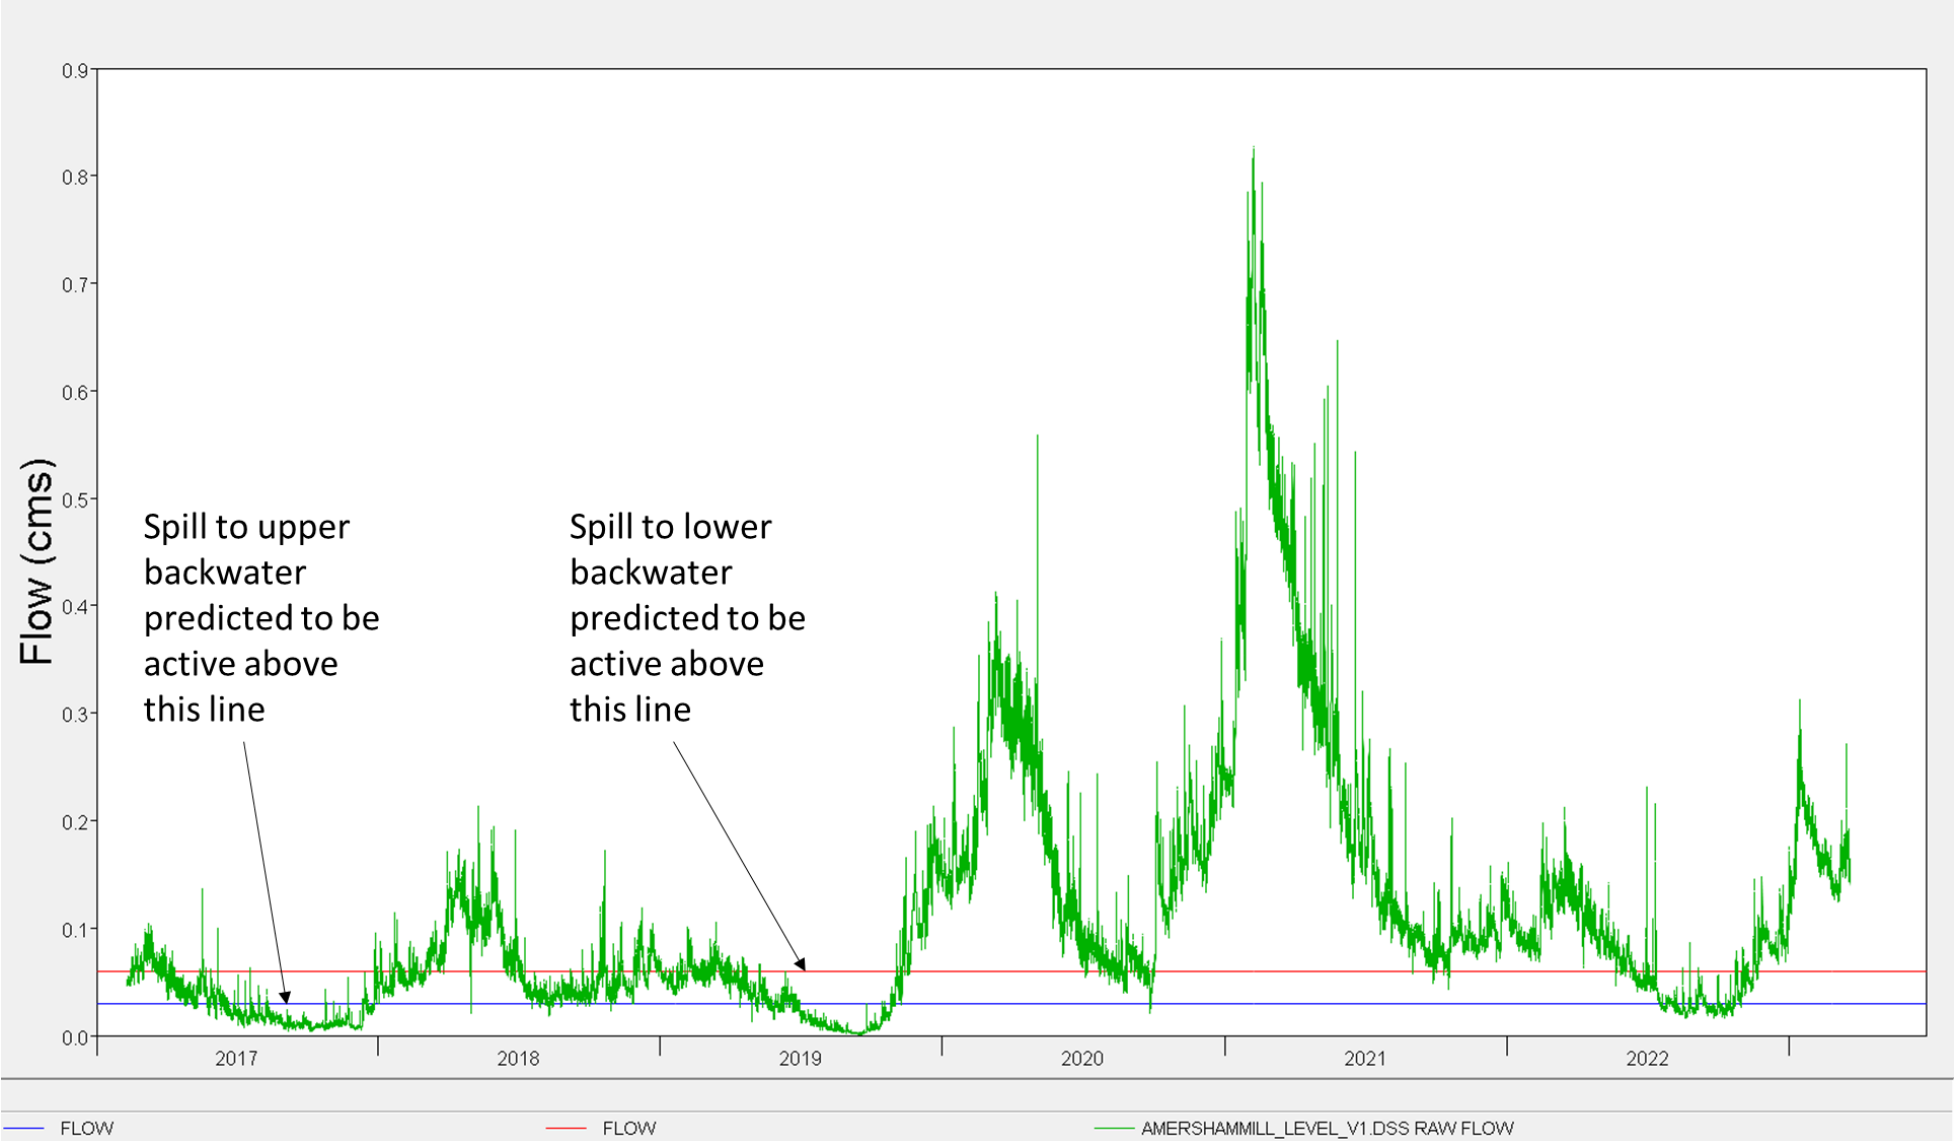
Backwaters at Pondwicks – when will they be wet and dry?
